September 1982

Crash Tests of Four Low-Wing Twin-Engine Airplanes With Truss-Reinforced Fuselage Structure

M. Susan Williams
and Edwin L. Fasanella

*Langley Research Center
Hampton, Virginia*

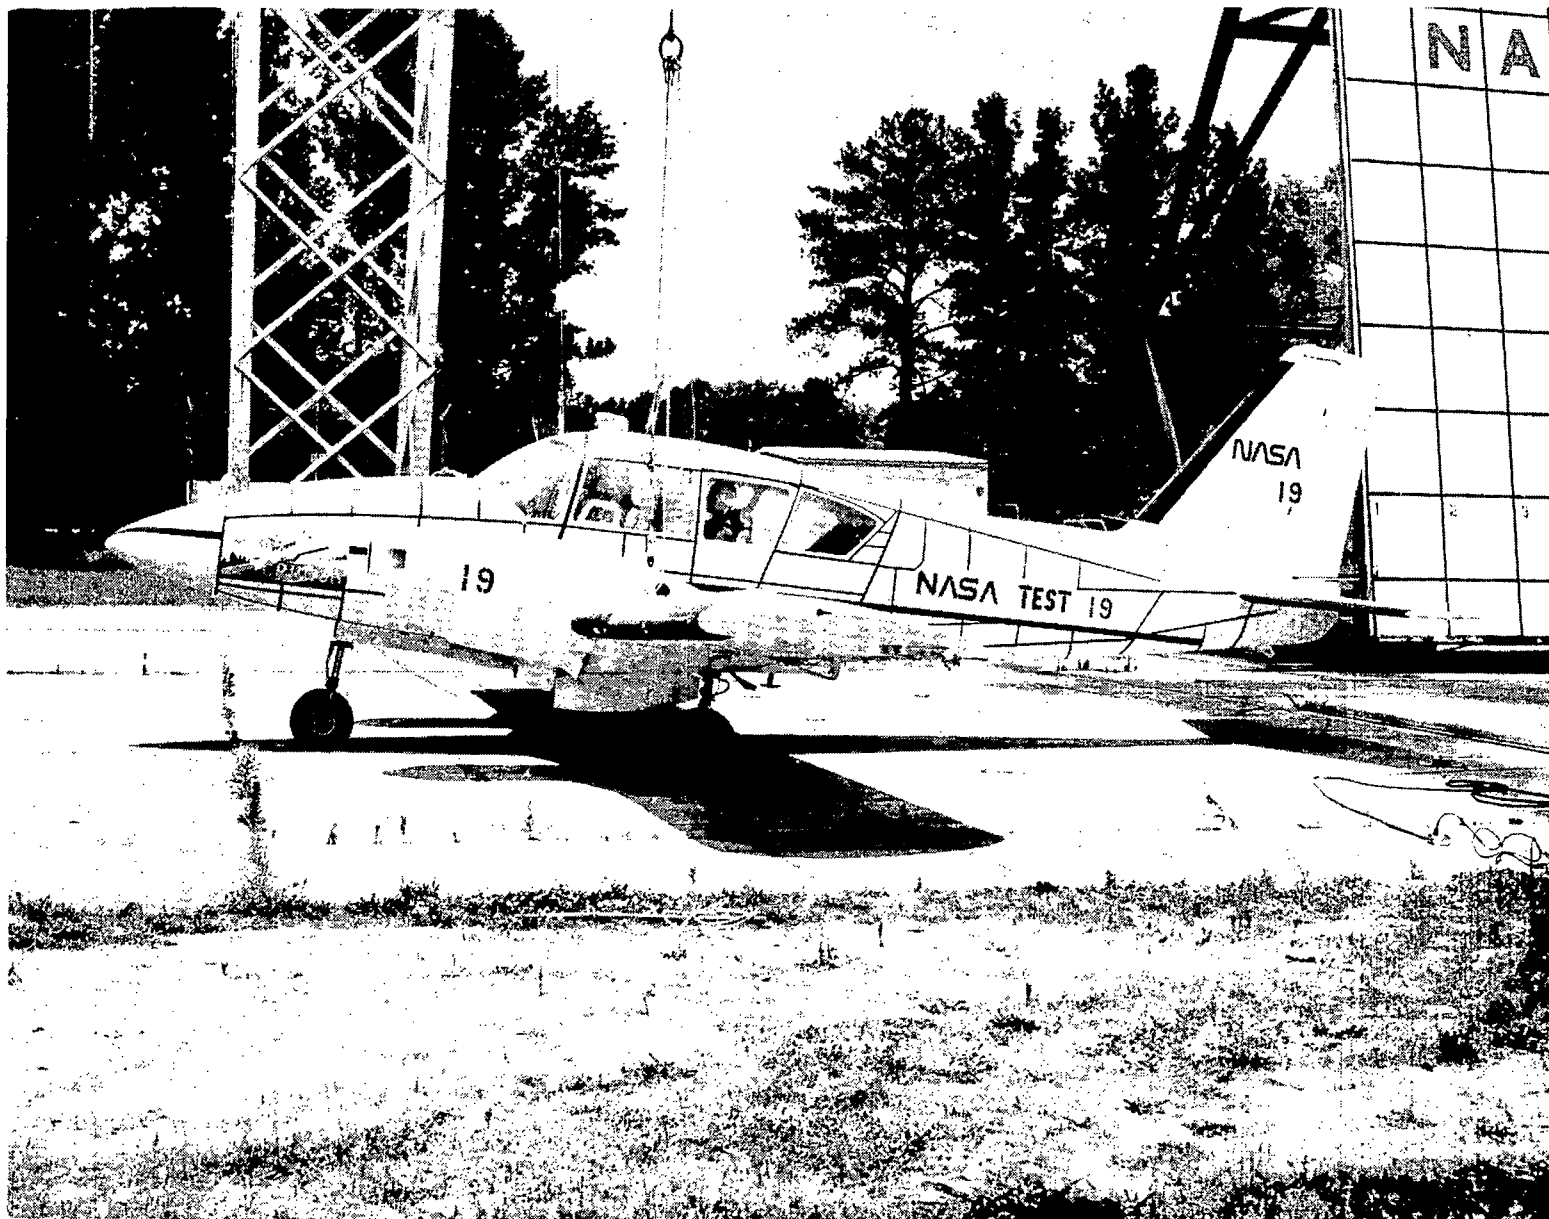
Figure 7.- Typical airplane test specimen.

The airplane specimens used for the tests (fig. 7) were identical six-place, low-wing, twin-engine, general-aviation airplanes with masses of 2237 kg (flat-impact test), 2193 kg (15° nose-down test), 1993 kg (first 30° nose-down test), and 2293 kg (second 30° nose-down test). The airplanes were of aluminum structure with a welded tubular-steel truss inside the cabin. The four airplane specimens were complete except for upholstery and avionics. The fuel tanks were filled with water to simulate the fuel mass. Spoilers were attached to the wings to minimize the aerodynamic lift. The exterior and interior of the airplane specimens were painted to enhance photographic contrast, and black lines were painted over rivet lines to emphasize the underlying structure.

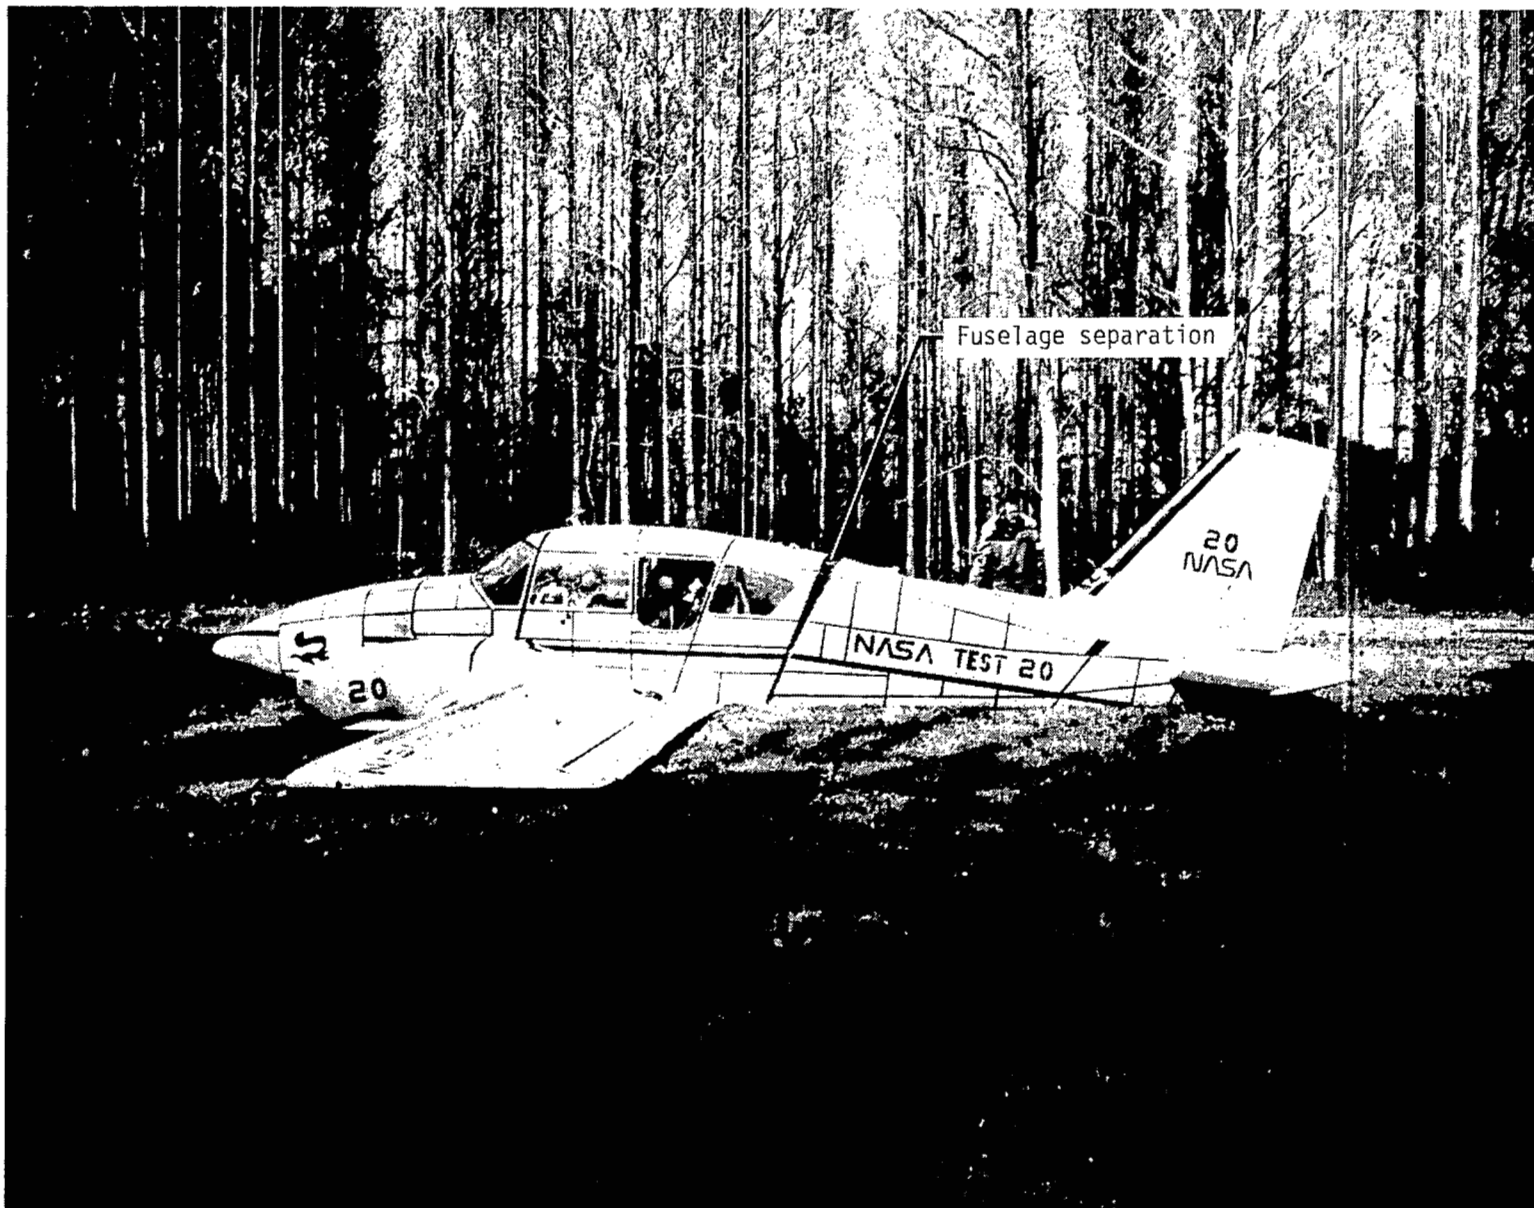
(e) Port-side view of airplane.

(f) Port-side external damage.

(g) Underside view of airplane showing crash damage.

The final position of the airplane and the overall damage to the structure as viewed from the port side is shown in figure A2(e). Separation of the fuselage just aft of the internal tubular truss is attributed to rivet shear, and the floor is the only structure holding the fuselage together. (See fig. A2(f).) Compression loading of the bottom of the fuselage and nacelles is shown in figure A2(g).

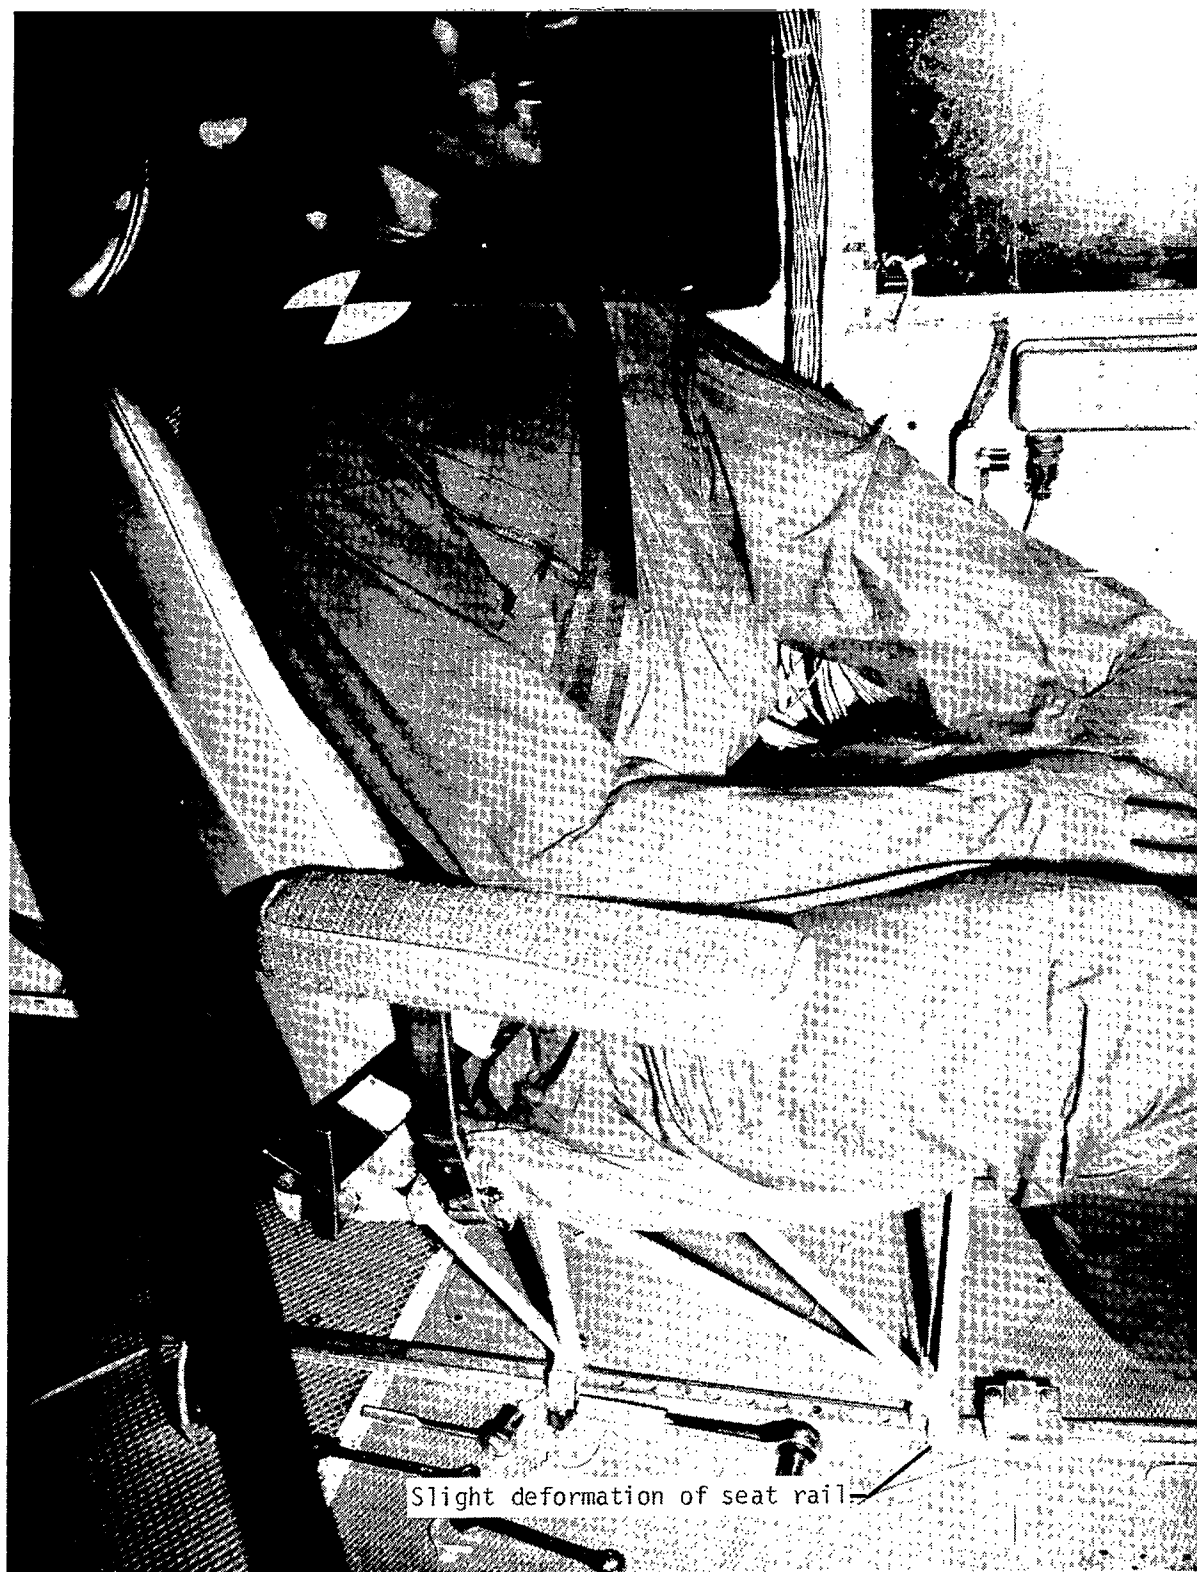
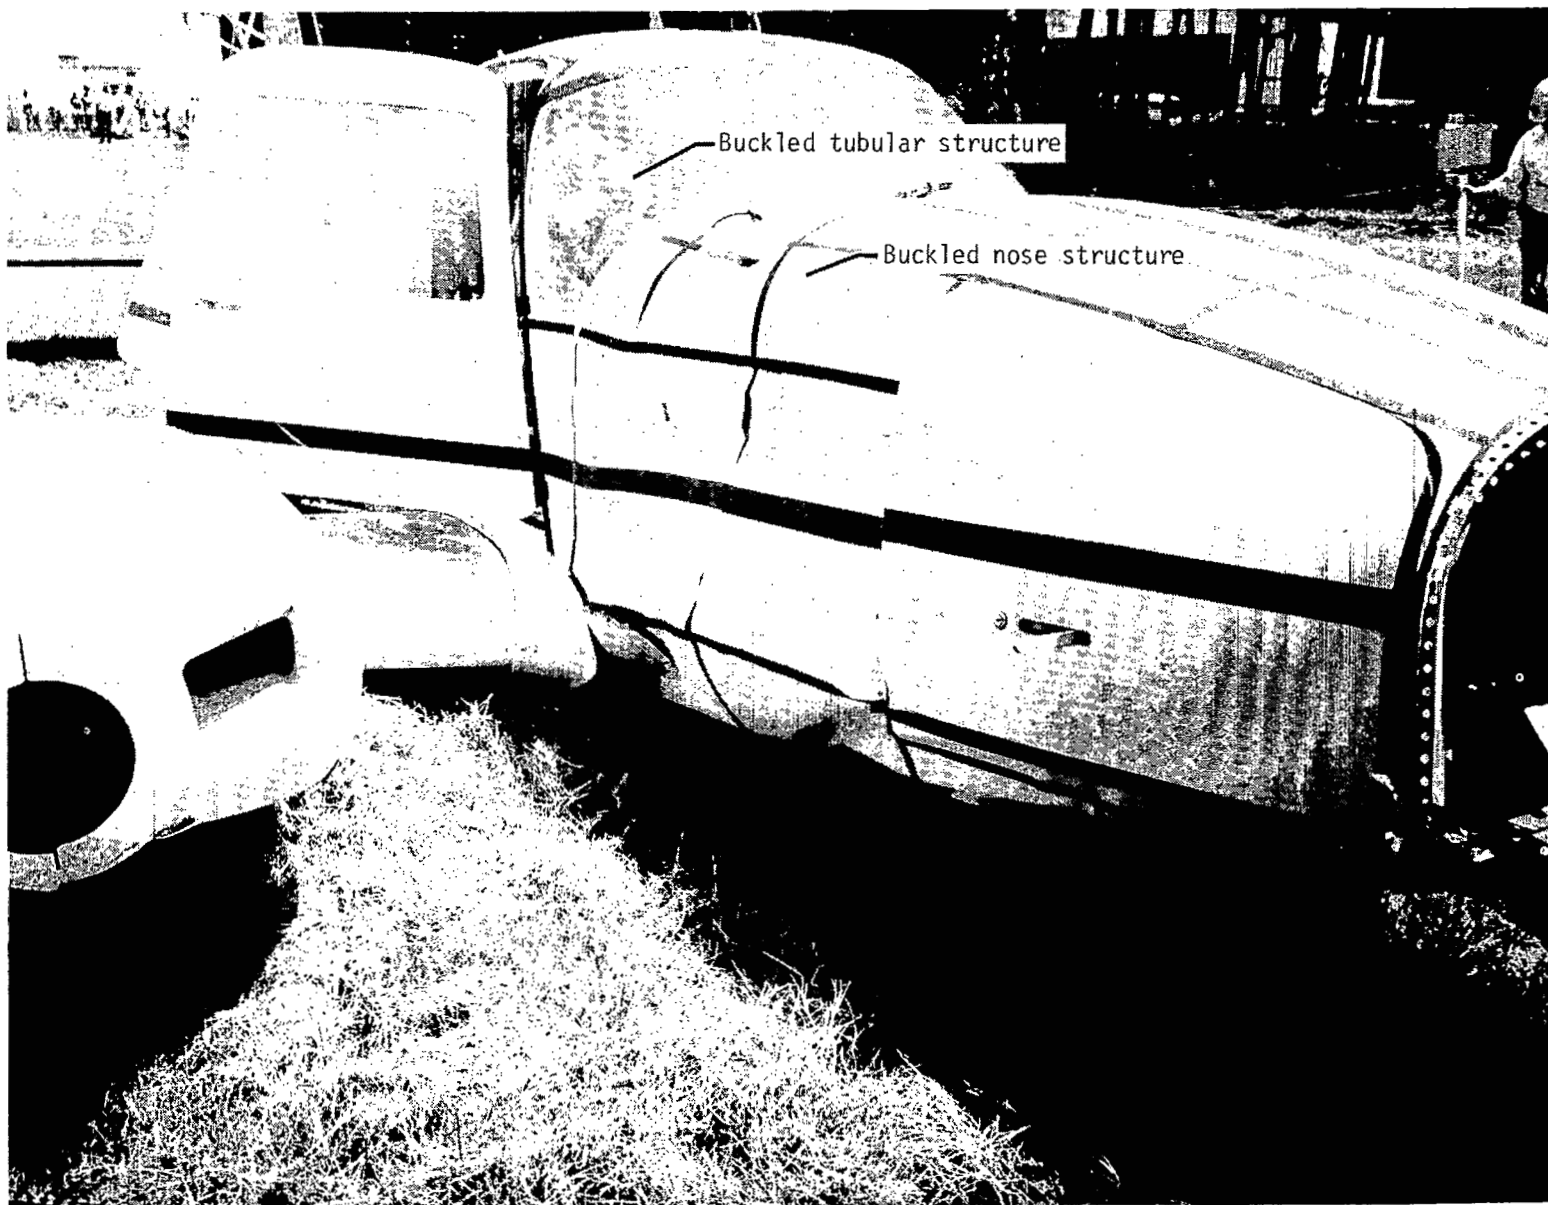
(a) Postcrash view of crew compartment.

(b) Postcrash view of copilot's seat.

(c) Postcrash close-up of passenger's seat.

(d) Postcrash view of passenger's seat.

(e) Postcrash view of cabin after seat removal.

(f) Starboard view of airplane.

(g) Underside view of damage to fuselage and nacelles.

Postcrash photographs from the 15° nose-down test are presented in figure B2. The livable volume was maintained in the crew and passenger positions during the crash impact. The crew and passenger seats showed no apparent postcrash damage except for the rubber-membrane seat pans, which failed at several attachment points (figs. B2(a) through B2(d)). Both inboard crew seat rails were broken by the compressive loading of the legs on the rails (fig. B2(a)). The first-passenger seat rails were slightly deformed. Figure B2(e) shows an overall interior postcrash view of the cabin floor from rear to front after the seats were removed. The floor showed some deformation in the crew and passenger locations.

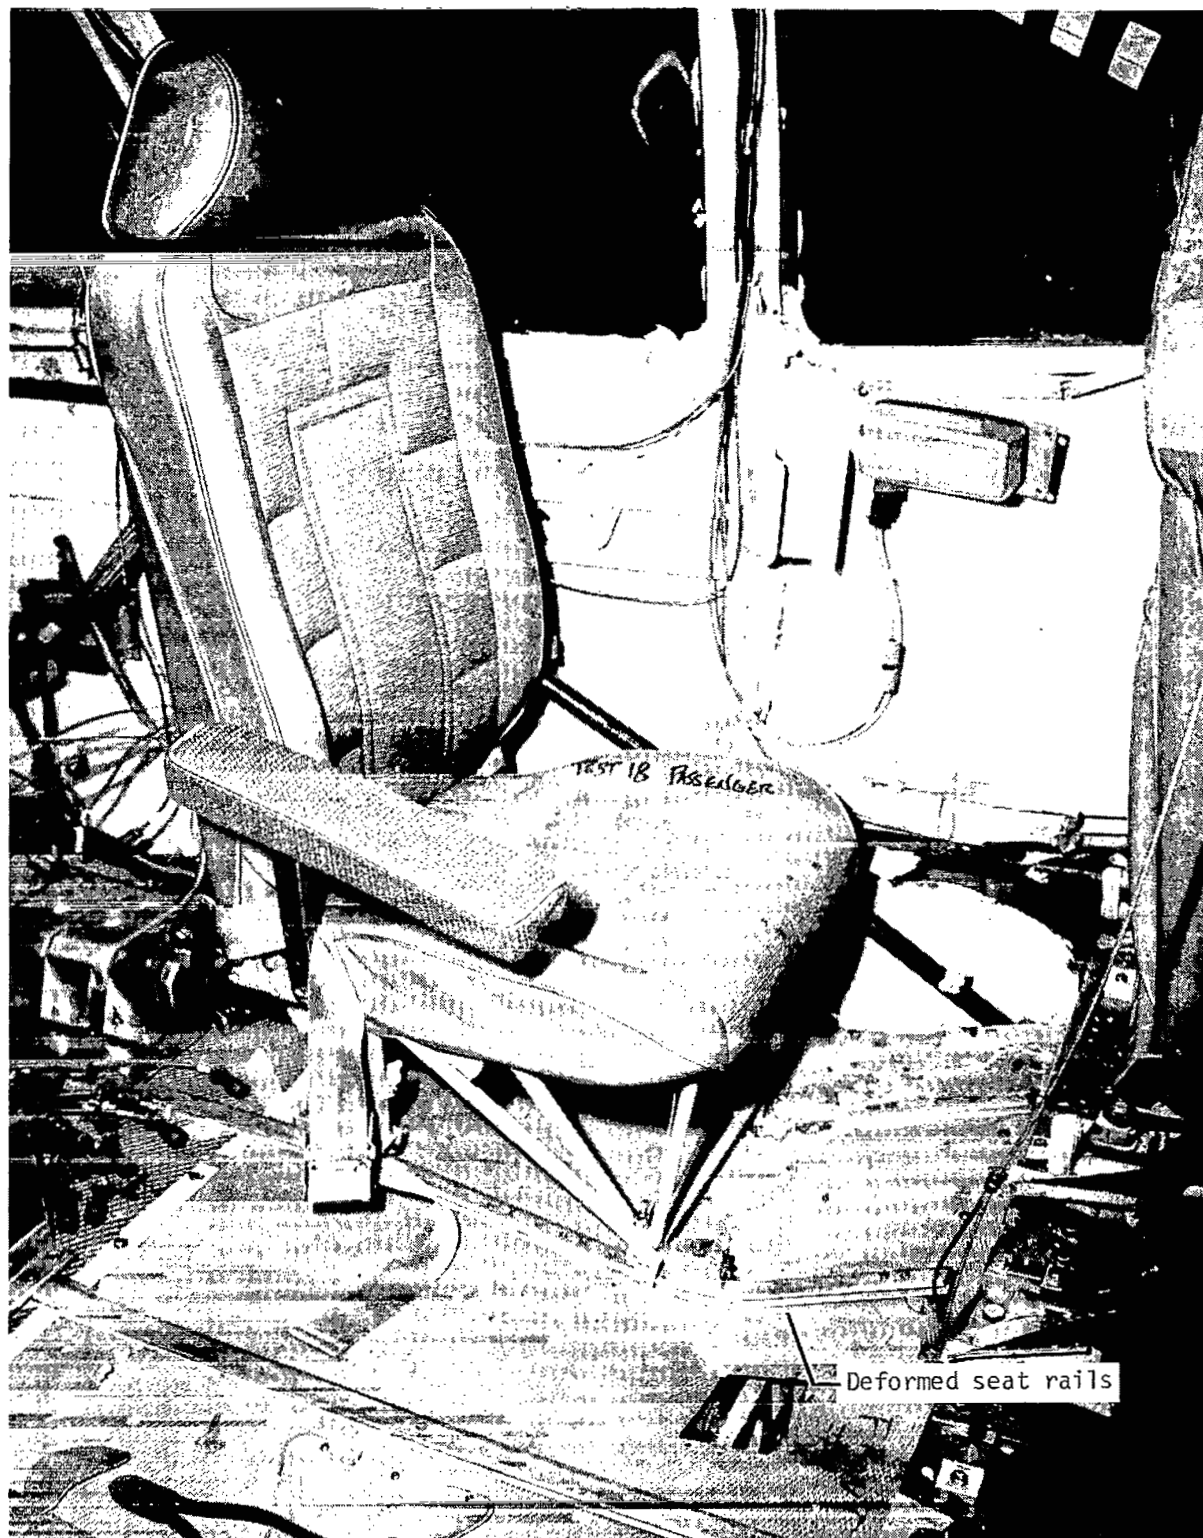
(f) Postcrash view of passenger's seat in first 30° nose-down test.

(g) First passenger's position after second 30° nose-down test.

(h) Second passenger's seat in second 30° nose-down test.

Postcrash photographs of the passenger seats are shown in figures C3(f) through C3(h). The passenger seats in both tests showed little damage upon postcrash inspection. The rubber-membrane seat pans failed in these seats, just as they had done in the crew seats. The passenger's seat in the first test and the second passenger's seat in the second test remained attached to the seat rails during the impact; however, the first passenger's seat in the second test completely detached from the seat rails. This passenger came to rest facing the port side of the airplane still strapped to the seat (fig. C3(g)).

Postcrash inspection of the first passenger's seat in the second 30° nose-down test revealed that the bolt in each rear-leg attachment clamp was not fully tightened. This situation allowed the rear-leg attachments to spread, and consequently the seat disengaged from the track. In the first test, the passenger's outboard seat rail cracked, pulled up in the rear, and depressed in the front. The passenger seat rails in the second test showed similar deformation, but did not fracture.

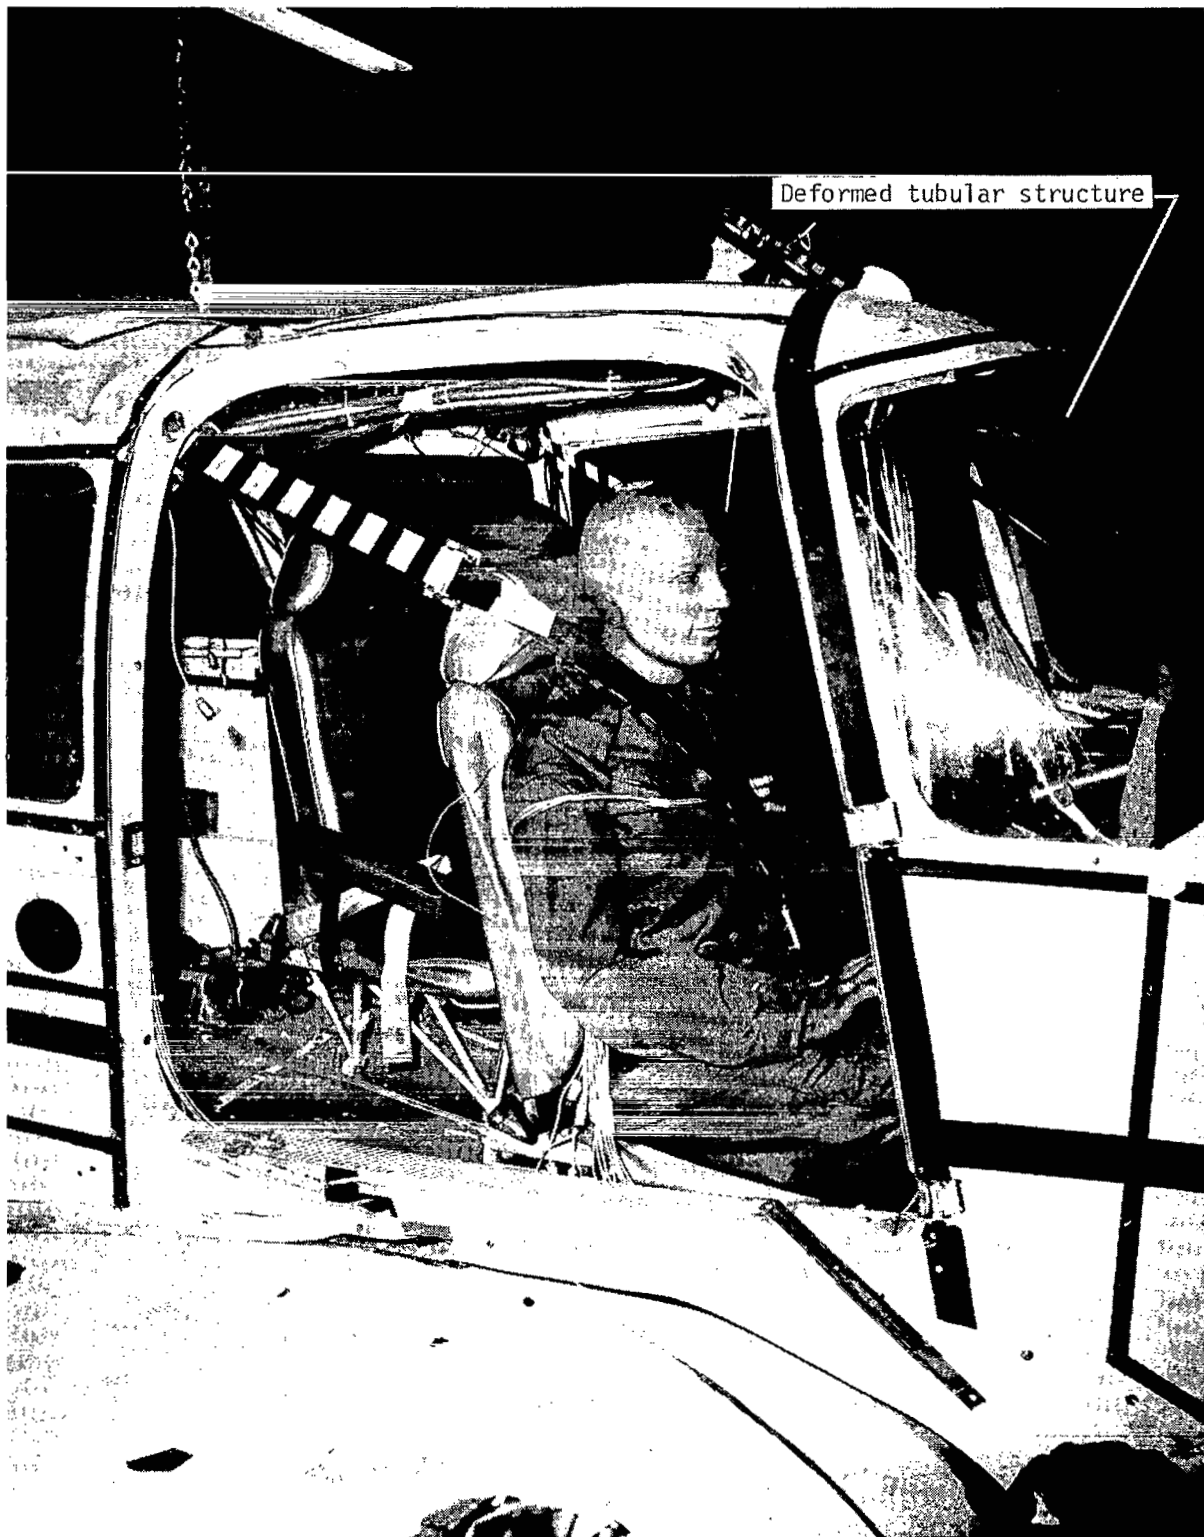
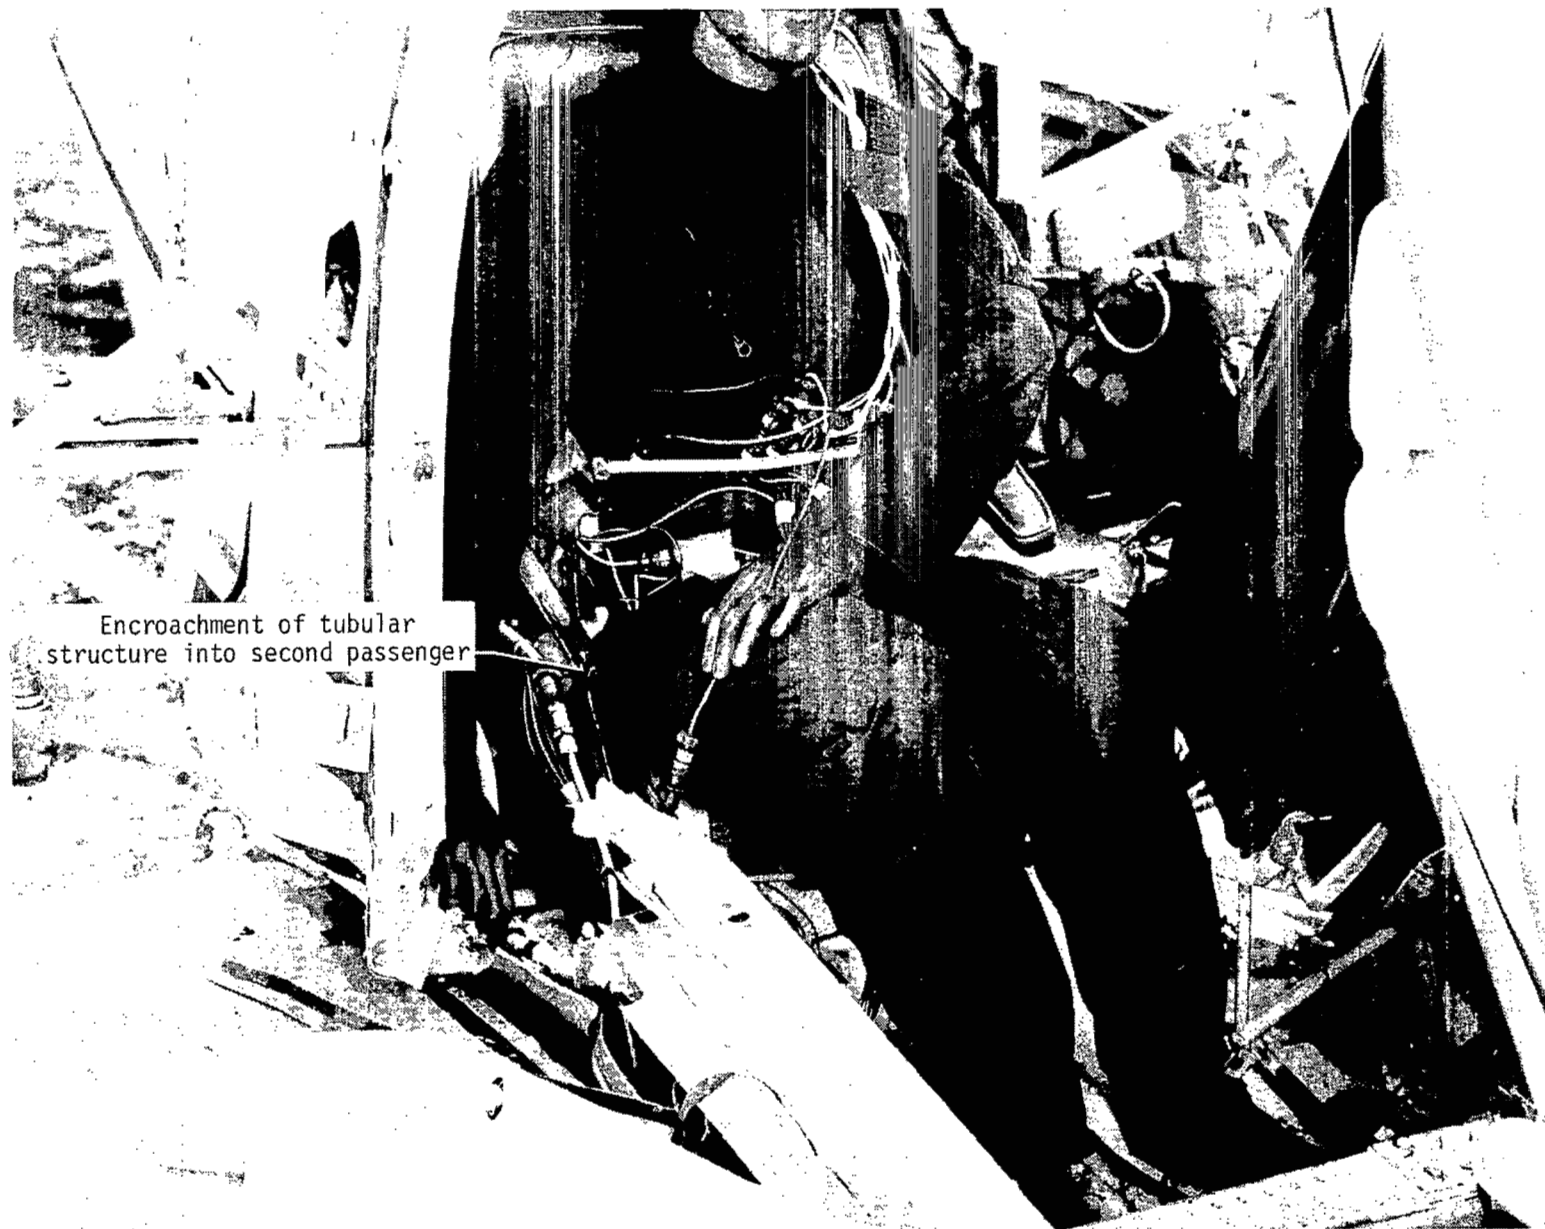
(i) Forward view of cabin after first 30° nose-down test.

(j) Postcrash view of cabin after first 30° nose-down test.

(k) Forward view of cabin after second 30° nose-down test.

Encroachment of tubular
structure into second passenger

(1) Second passenger's position after second 30° nose-down test.

Overall damage to the instrument panel, floor, and tubular-steel truss structure in each test is shown in figures C3(i) through C3(l). The tubular-truss structure was bent and fractured in many of the same locations for the two tests. In the second test, the tubular-truss structure bent inward into the leg of the second passenger (fig. C3(l)).

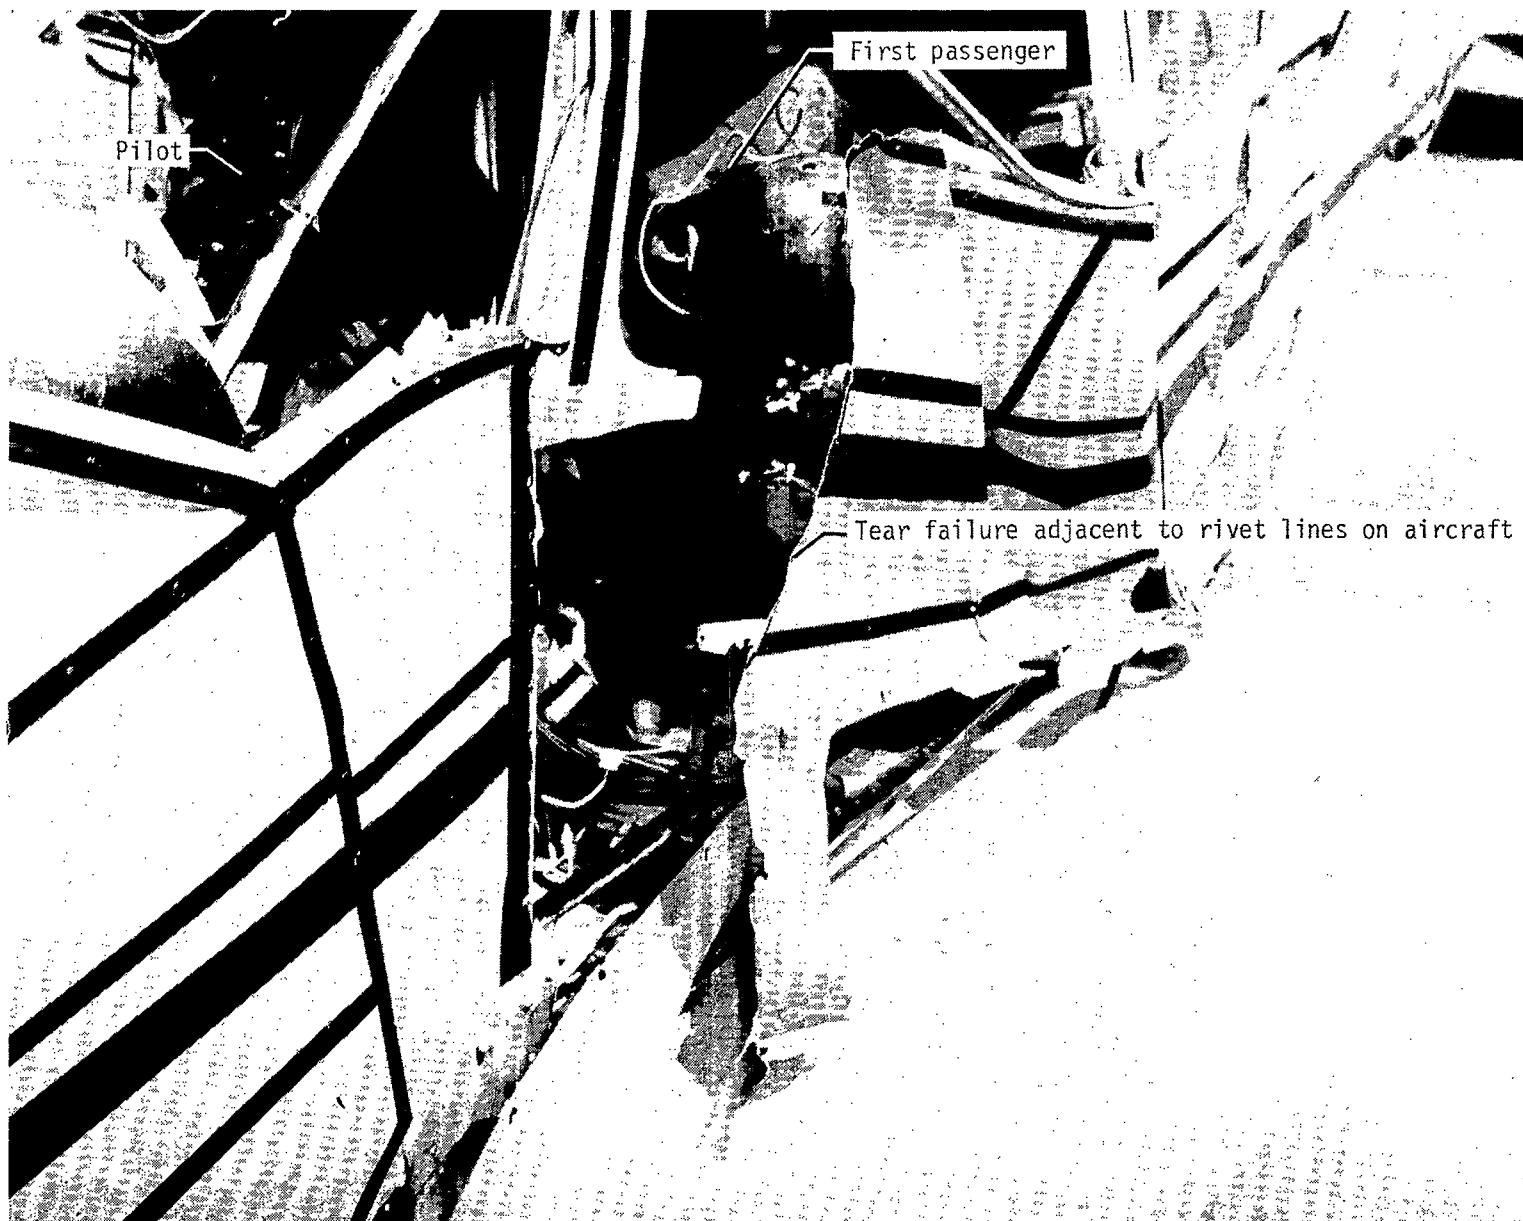
(m) Port-side view of airplane after first 30° nose-down test.

(n) Port-side view of airplane after second 30° nose-down test.

Damage to the port side of the airplanes is shown in figures C3(m) and C3(n). This damage was similar in the two tests but more severe in the second test. Separation occurred along the side of the fuselage and along the fuselage-wing junction. Some plexiglas windows were broken during the impact. On the starboard side of the airplane in both tests, the door detached from the fuselage and was lying on the wing. Also, the steel tubular-truss structure bent outward and penetrated the side of the fuselage.
